PRELIMINARY INSTRUCTIONS FOR INDICATION A TRIP OF THE OVERVOLTAGE UNIT (SPD'S) ON THE FRONIUS TAURO

Publisher: Fronius International GmbH – TechSupport International
Version: 01_EN
Date: 03 / 2021

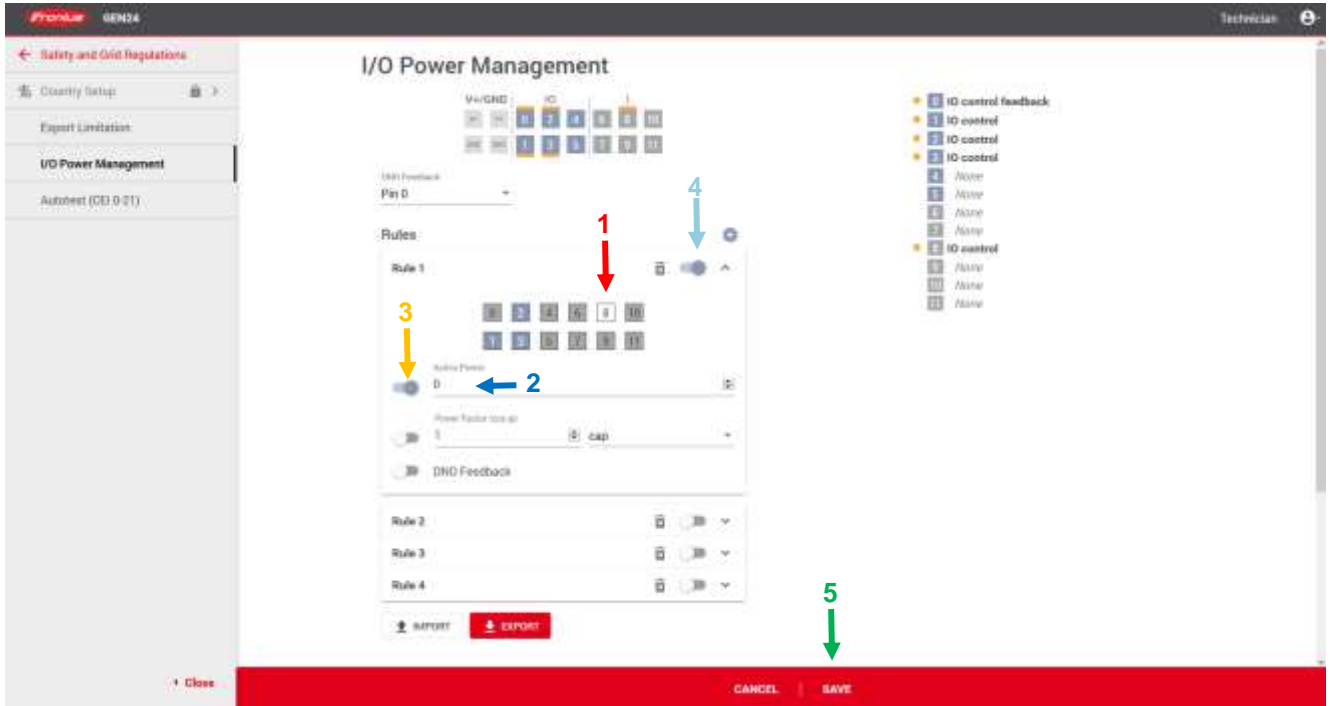
Step 4

Activate the active power function at a free rule (in the example rule 1 - IO control position 8). Depending on the setting of the value, in this case it was set to 0% output power of the inverter, the inverter regulates its output power.

Please note that the signal line of the SPDs is connected to position 8 ex works. If you change the connection, you must take this into account here accordingly. In the example we reduce the active power to an output power of 0%. This ensures that you also see this behavior very clearly in the Solar.web at Archive. Since this is a very drastic measure, you are of course free to adjust this value for yourself.

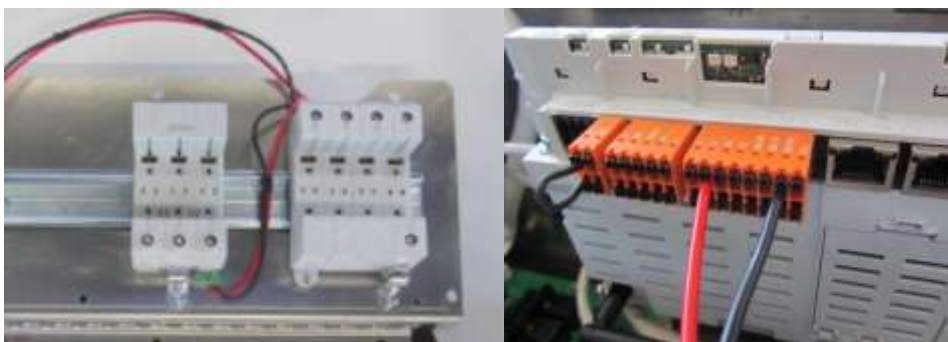
Example pictures:

If the overvoltage protection is triggered, this rule reduces the inverter to an output power of 0% and at the same time a state code 1003 is ejected. You can see this error message either in Solar.web or via the data communication interface of the inverter.
