# GEN24 Offline Causes and solutions

Version 01 08/2023

Business Unit Solar

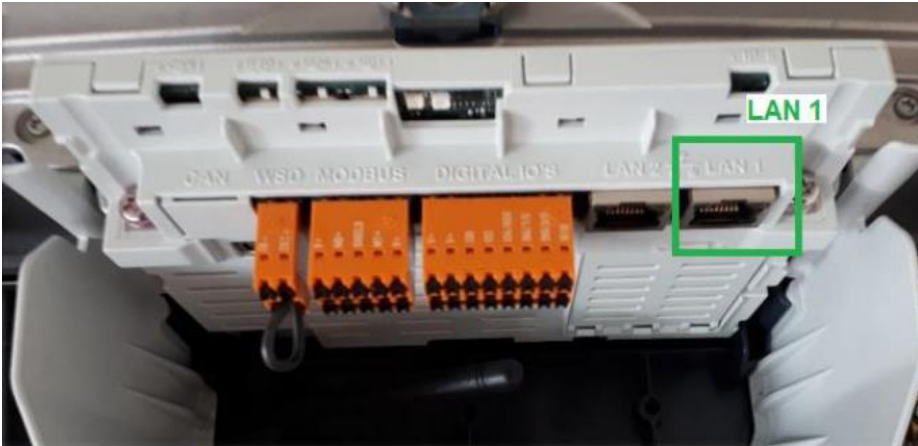
Ensure that the LAN 1 Ethernet socket is used.

Figure 7 Socket LAN 1
