Fronius Galvo 1.5-1 – 3.1-1 208-240

USB update *fro28171.upd*

Software versions:

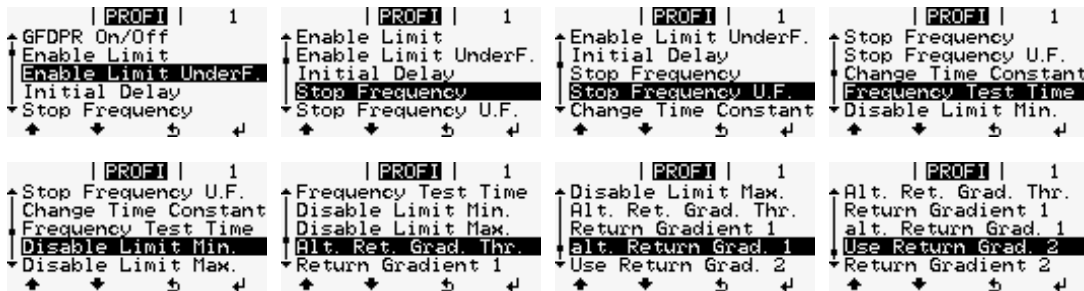
- Extension of the P (f) settings for the GDPR function by the following parameters:
Start frequency at underfrequency
Stop frequency at overfrequency
Stop frequency at underfrequency
Frequency Test Time (Duration of frequency monitoring before return to nominal power)
Disable Limit min (lower limit for frequency monitoring)
Alternative Return Gradient Threshold (Percentage drop of nominal power, from which "Alternative Return Gradient 1" is activated)
Alternative Return Gradient 1 (Alternative return gradient to maximum power in %/s, based on the difference between frozen and lowest power)
Use Return Gradient 2 Mode (Mode: 0 ... 'Return Gradient 1' or 'Return Gradient 1 Alternative' is used, 1 ... 'Return Gradient 2' is used)
Return Gradient 2 (Further return gradient to the maximum power in %/s, based on nominal power, if this is activated)
